# Heritage (Decision about Registration of the ‘Expansion’ Mosaic Mural Wall, Braddon) Notice 2013 (No 2)\*

Notifiable Instrument NI2013–500

'Expansion' Mosaic Mural Wall

(Part) Block 9 Section 8 Braddon, ACT

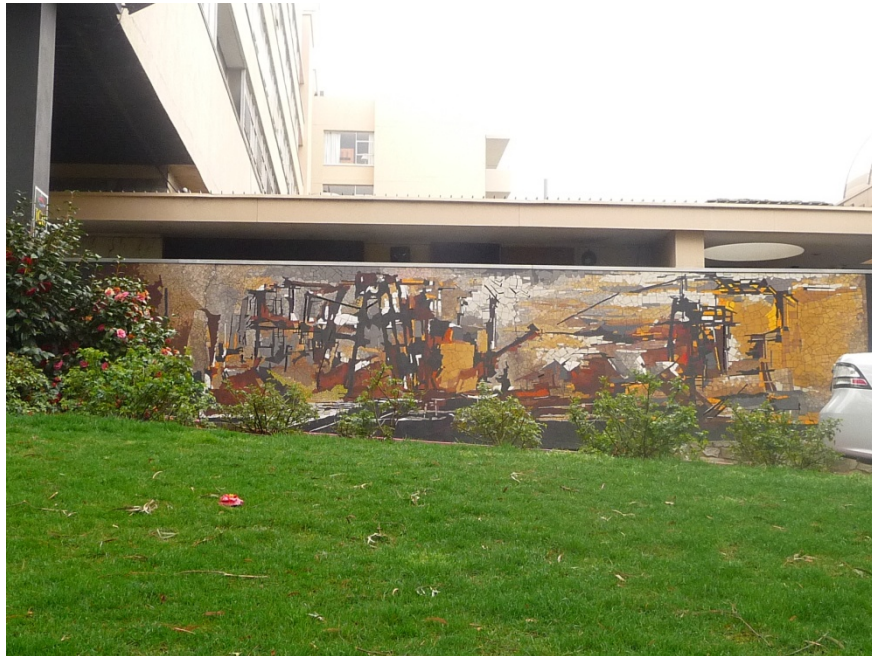
Figure 1. 'Expansion' Mosaic Mural Wall as seen from Northbourne Avenue  
(ACT Heritage Unit, Sep 2012).

The 'Expansion' Mosaic Mural Wall is situated on the southern side of the main entrance to the Canberra Rex Hotel (2013) and is set approximately 10m back from the main road (Figure 1). The wall faces Northbourne Avenue and while it is partially concealed by vegetation, including trees, it can be fleetingly viewed directly in front of the hotel from the road and pathway as one approaches the city travelling south (Figures 1 and 2). The Mural is constructed from hand-cut, irregular shaped glass, vitreous and porcelain tiles and measures 2.3m in height and 12.3m in length.

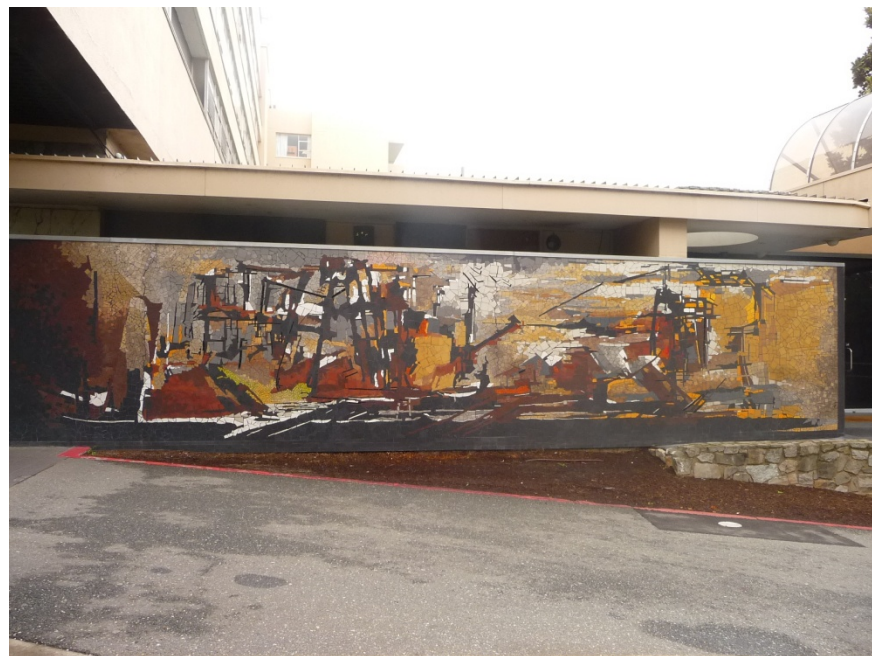
Figure 2. 'Expansion' Mosaic Mural Wall as seen from the driveway of the Hotel (2013 Canberra Rex  
Hotel)  
(ACT Heritage Unit, Sep 2012).

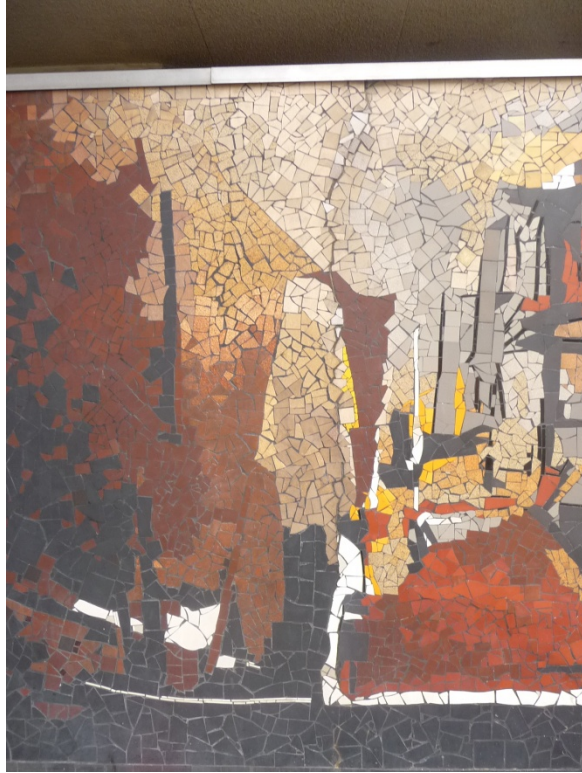
Figure 3. Repaired Structural Crack 1, situated in sections 5 and 6 (ACT Heritage Unit, Sep 2012).

The Mural's construction involved the preparation of a full sized painted cartoon onto which Lewers glued each hand-cut irregular shaped glass, vitreous or porcelain tile face down. The colours and tones were selected in response to the hotel's external colour scheme of yellow, grey and black, to which the artist added earthy reds, white and brown (Figures 3, 4 and 5). The Mural was laid in sections on site under the artist's supervision.

Major structural damage was observed that included three large vertical structural cracks and one hairline crack across the Mural. In 2009, urgent stabilisation works were recommended to prevent further loss of

In 2010, the Mural was restored by Conservation Works Pty Ltd. The treatment comprised the following; the two large cracks were repaired and sealed, its surface was clean, washed with a non-ionic detergent and tap water; the top capping was stabilised, drummy tiles were consolidated and missing tiles, replaced, a cement based black sand grout was used to repair mortar loss, and a tree growing towards the centre of the Mural was removed (Mitchell 2010). In addition, during the treatment it was observed that the footings were 'partially unsupported', as the wall is constructed on a slab with a cantilevered edge; however, this is not considered to be the cause of the structural issues. A large void was also filled in with a "standard brickies mortar" mix (Mitchell 2010). These repairs were funded by a grant from the ACT Heritage Unit.

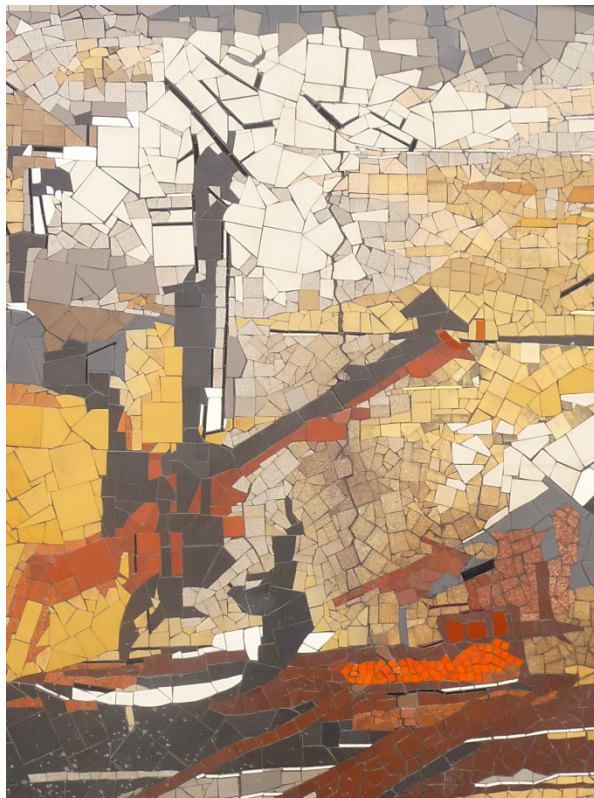
Figure 4. Repaired structural crack of sections 11 and 12 (ACT Heritage Unit, Sep 2012).

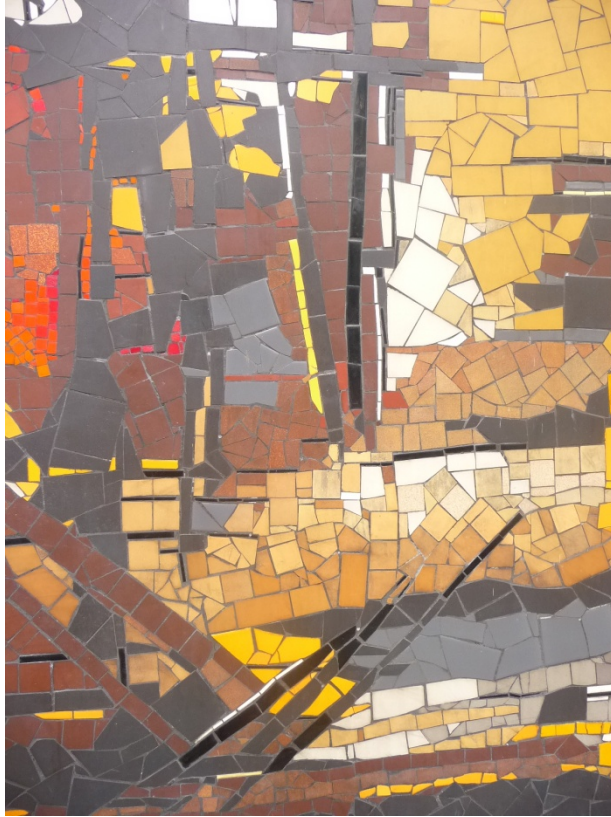
Figure 5. Close up of the Mural, illustrating its abstract form and stark colour combinations of bright and earthy hues, indicative of Margo Lewer's style (ACT Heritage Unit, Sep 2012).
