# Heritage (Decision about Registration of the 'Expansion' Mosaic Mural Wall, Braddon) Notice 2013

'Expansion' Mosaic Mural Wall, Braddon

(Part) Block 1 Section 8 Braddon, ACT

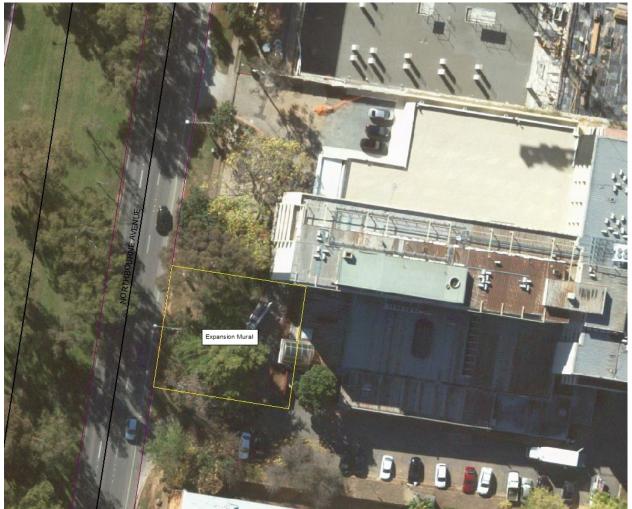
Figure 1. Location of the Mural and open character landscape area between the Mural and Northbourne Avenue, at the Rex Hotel, Northbourne Avenue. Boundary is indicated by yellow line. Map is not to scale.

The 'Expansion' Mosaic Mural Wall is situated on the southern side of the main entrance to the Canberra Rex Hotel (2013) and is set approximately 10m back from the main road (Figures 1 and 2). The wall faces Northbourne Avenue and while it is partially concealed by vegetation, including trees, it can be viewed directly in front of the hotel from the road and pathway as one approaches the city travelling south (Figures 2 and 3). The Mural is constructed from hand-cut, irregular shaped glass, vitreous and porcelain tiles and measures 2.3m in height and 12.3m in length.

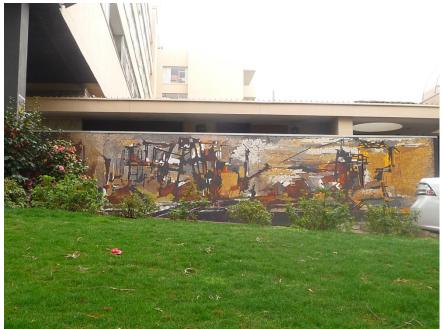
Figure 2. 'Expansion' Mosaic Mural Wall as seen from Northbourne Avenue (ACT Heritage Unit, Sep 2012).

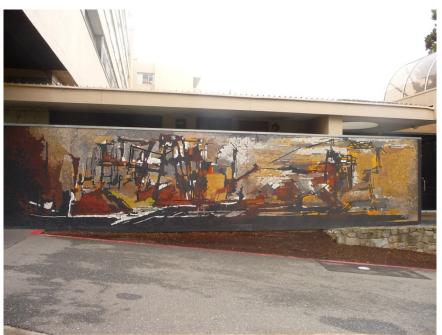
Figure 3. 'Expansion' Mosaic Mural Wall as seen from the driveway of the Rex Hotel (ACT Heritage Unit, Sep 2012).

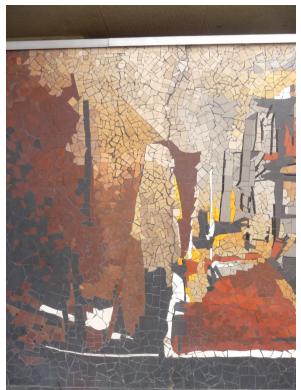
Major structural damage was observed that included three large vertical structural cracks and one hairline crack across the Mural. In 2009, urgent stabilisation works were recommended to prevent further loss of tiles and extension of drummy areas. In addition, minor structural problems were also observed including minor loss of grout between the tiles across the extent of the Mural, with higher loss in areas of structural cracking, cracked tiles which date from time of manufacture, areas of drummy tiles and areas of chipped and impact damaged tiles. Also, it was observed that the surface of the Mural exhibited applied and incised graffiti, general dirt and cobwebs, extensive paint splatter from repainting of the building and extensive mould and algae staining which was particularly heavy towards the southern end of the Mural.

Figure 4. Repaired Structural Crack 1, situated in sections 5 and 6 (ACT Heritage Unit, Sep 2012).

In 2010, the Mural was restored by Conservation Works Pty Ltd. The treatment comprised the following; the two large cracks were repaired and sealed, its surface was clean, washed with a non-iconic detergent and tap water; the top capping was stabilised, drummy tiles were consolidated and missing tiles, replaced, a cement based black sand grout was used to repair mortar loss, and a tree growing towards the centre of the Mural was removed (Mitchell 2010). In addition, during the treatment it was observed that the footings were 'partially unsupported', as the wall is constructed on a slab with a cantilevered edge; however, this is not considered to be the cause of the structural issues. A large void was also filled in with a "standard brickies mortar" mix (Mitchell 2010). These repairs were funded by a grant from the ACT Heritage Unit.

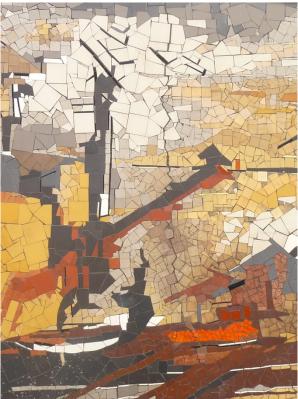
Figure 5. Repaired structural crack of sections 11 and 12 (ACT Heritage Unit, Sep 2012).

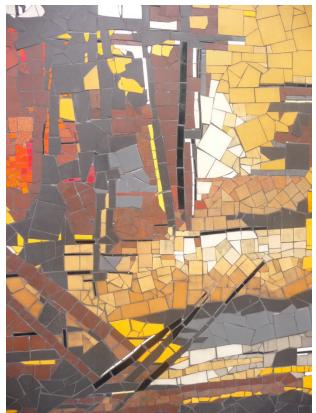
The Mural's construction involved the preparation of a full sized painted cartoon onto which Lewers glued each hand-cut irregular shaped glass, vitreous or porcelain tile face down. The colours and tones were selected in response to the hotel's external colour scheme of yellow, grey and black, to which the artist

added earthy reds, white and brown (Figures 4, 5 and 6). The Mural was laid in sections on site under the artist's supervision.

Figure 6. Close up of the Mural, illustrating its abstract form and stark colour combinations of bright and earthy hues, indicative of Margo Lewer's style (ACT Heritage Unit, Sep 2012).
