Heritage (Decision about Provisional Registration of Robertson House, Oaks Estate) Notice 2014

**AUSTRALIAN CAPITAL TERRITORY
HERITAGE REGISTER
(Provisional Registration)**

Robertson House

Blocks 11-12 Section 7, Oaks Estate

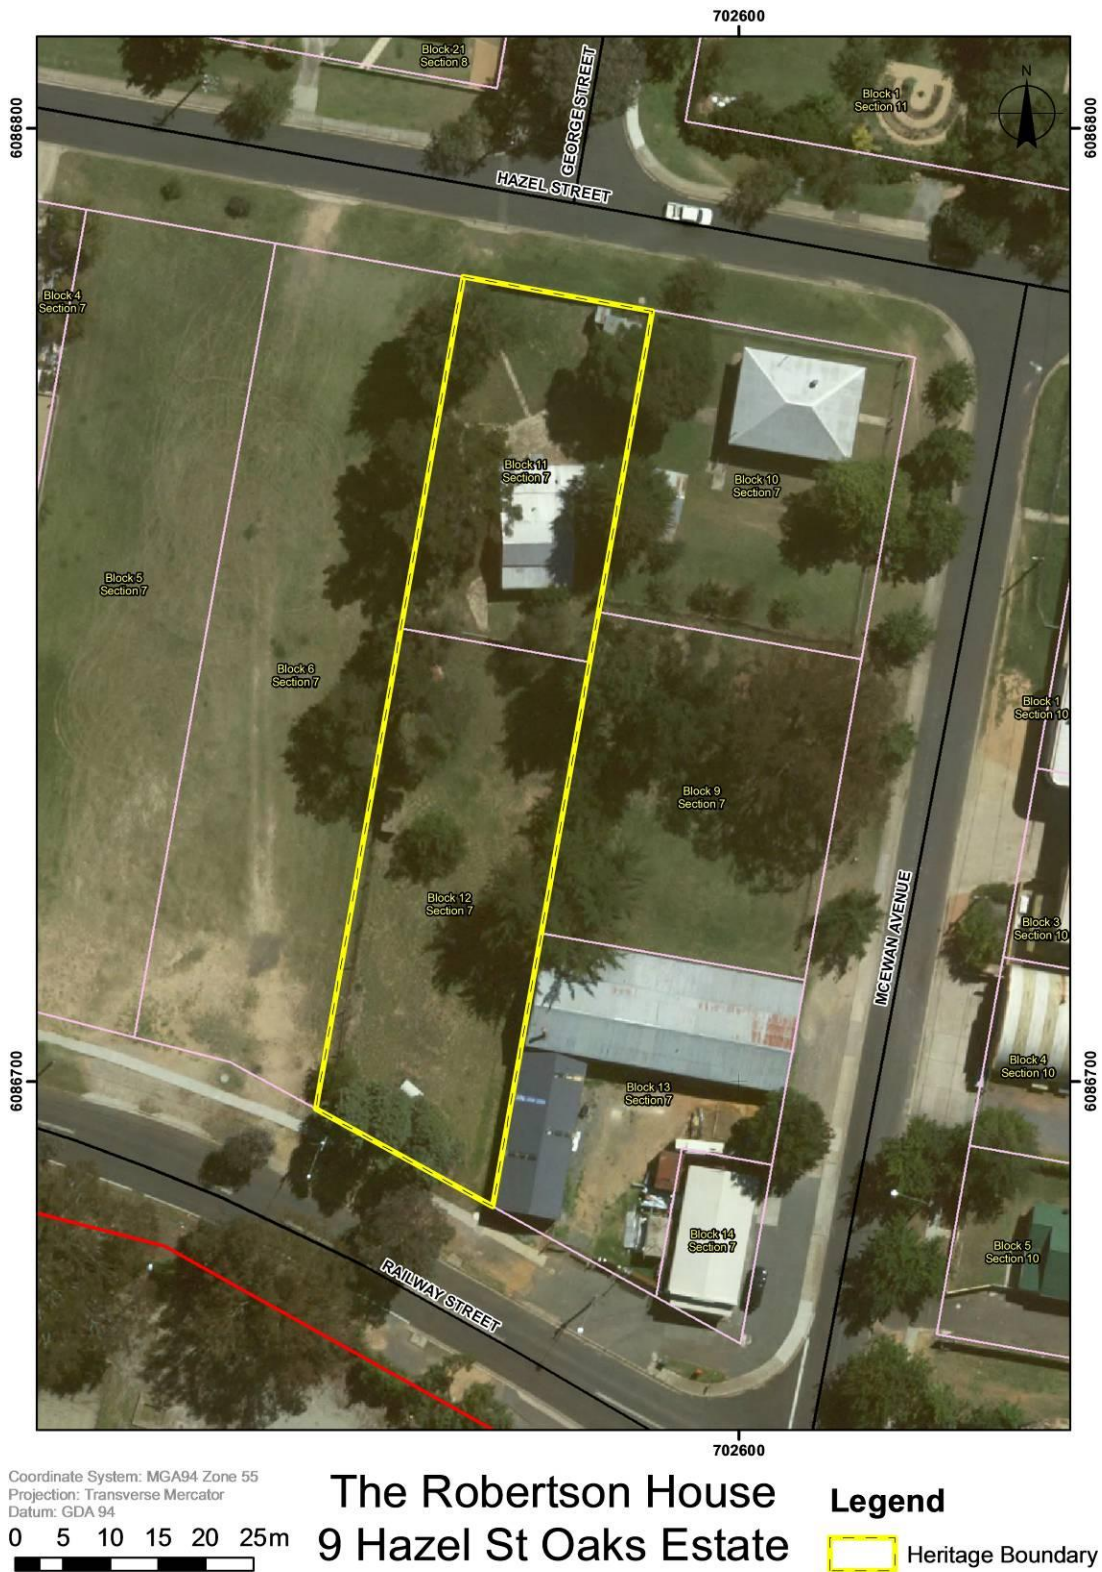
Figure 2 Robertson House provisional registration boundary.

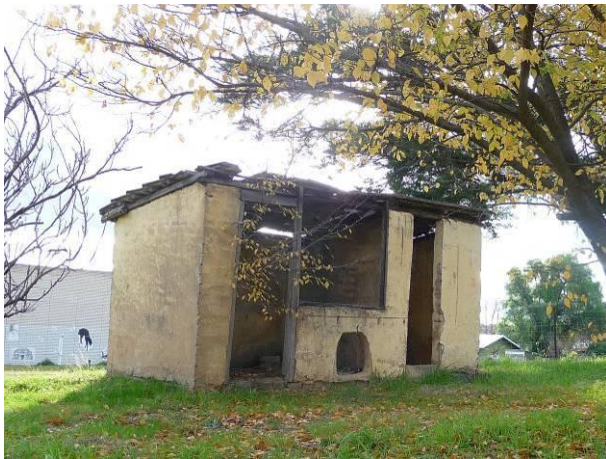
Figure 7 Fowl shed (ACT Heritage, 2014)

- The fowl shed, including the rendered concrete block walls and wood shingle roof.
 - The original block layout of Block 7 Section G, today Blocks 11 and 12 Section 7, including

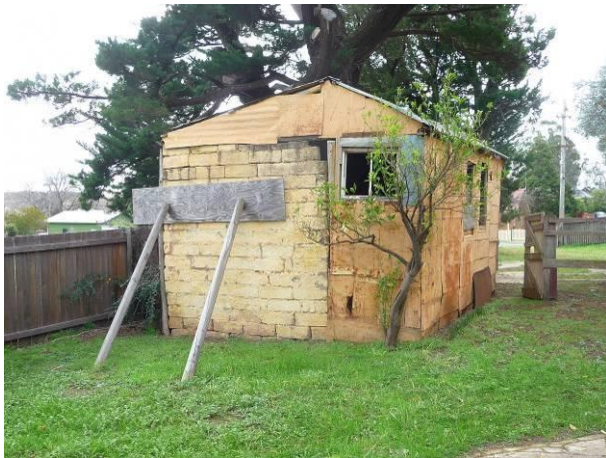
Figure 8 Southern end of western shed and laundry (ACT Heritage, 2014)

- The western laundry and workshop, including the original materials consisting of flattened kerosene tins, handmade concrete bricks, bush poles, and sheets of metal, as well as the workbench and the early-1960s Simpson 2-Speed Wringer-Washer; and

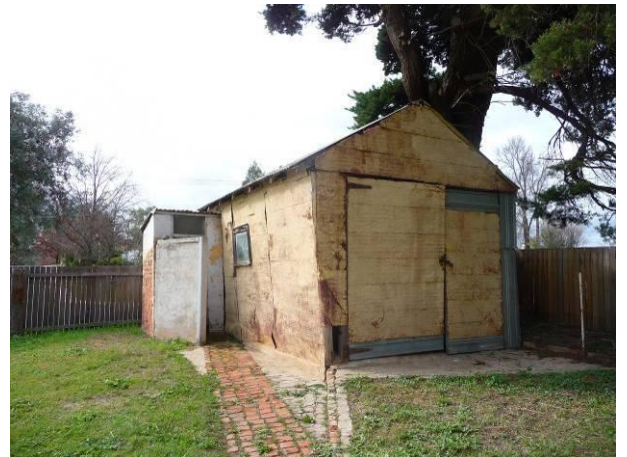
Figure 10 Northeast shed and toilet block (ACT Heritage, 2014)

- The brick chimney with the original fireplace and the late-1950s Warmray No. 2 wood-fired heater.
 - The outbuildings, including:
 - The northeast shed and attached toilet block, including the original material consisting of metal sheeting, brick offcuts and seconds, internal shelving and work areas;

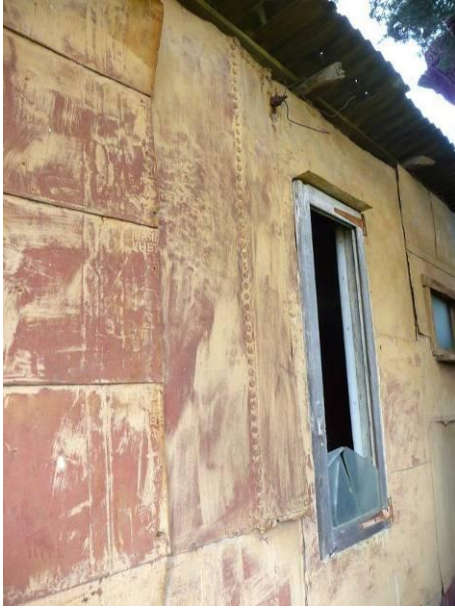
Figure 11 Tin cladding on east laundry facade (ACT Heritage, 2014)

The kerosene tins used to clad the outside and inside of the house and outbuildings come from various sources which are clustered by types in various locations. The earliest materials are located on the laundry building which has several kerosene tins marked out with “The Texas Company. Light of the Age. Best American Kerosene” (Figure 11) and a star symbol which is an early Texaco trademark used between 1903 and 1907 (Chevron, 2014). Also used in this structure are what appears to be sections of a metal shipping container (Figure 11). The adjoining shed contains tins marked by “B. I. O. Co. Ltd.” (Figure 12 and 13) – the British Imperial Oil Company, which operated as a subsidiary of Shell in Australia between 1905 and 1927, with the designs found at the Robertson House likely to correspond to the later part of this period (Shell, 2001). The tins used in the house are from the Vacuum Oil Company (Figure 13), which had a branch down the road from Robertson House from 1927 and were in Queanbeyan from the start of 1926.

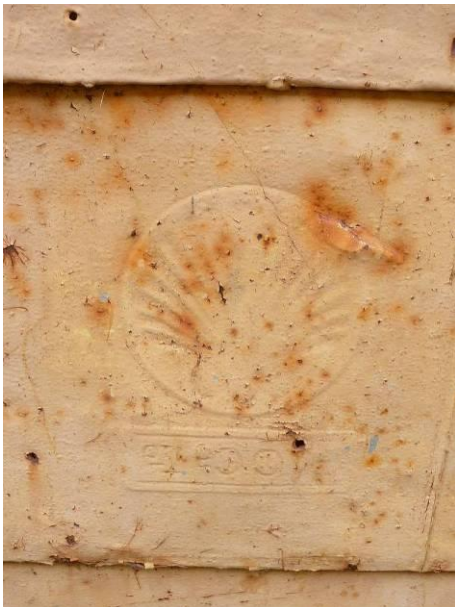
Figure 12 B.I.O. Shell kerosene tin cladding on western shed (ACT Heritage, 2014)

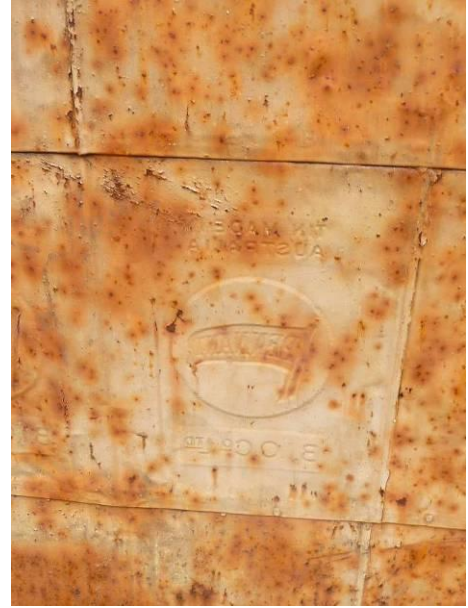
Figure 13 B.I.O. Pennant kerosene tin cladding on western shed (ACT Heritage, 2014)

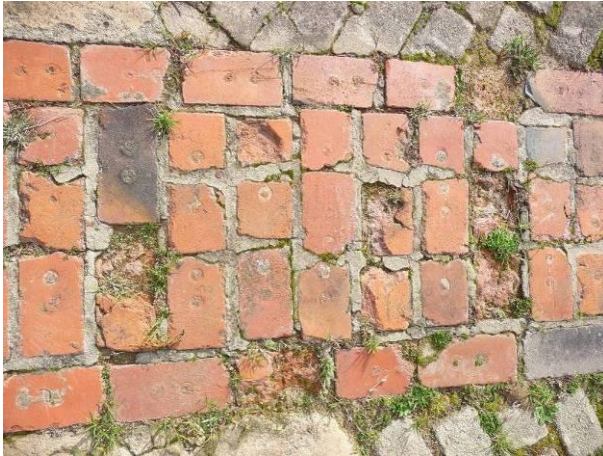
Figure 15 Brick paving (ACT Heritage, 2014)

- the siting of buildings within the blocks; and
 - the landscaping of the mature pine trees (*Pinus radiata*) along the boundaries, other established trees including peppercorn trees (*Schinus*), and the reclaimed brick paving.
-
