Planning and Development (EIS Exemption Application – Proposed mixed use development, Block 2, Section 67 Kingston – DA201700031) Public Consultation Notice 2017

Notifiable Instrument NI2017 - 511

This instrument is the *Planning and Development (EIS Exemption Application – Proposed mixed use development, Block 2, Section 67 Kingston – DA201700031) Public Consultation Notice 2017*.

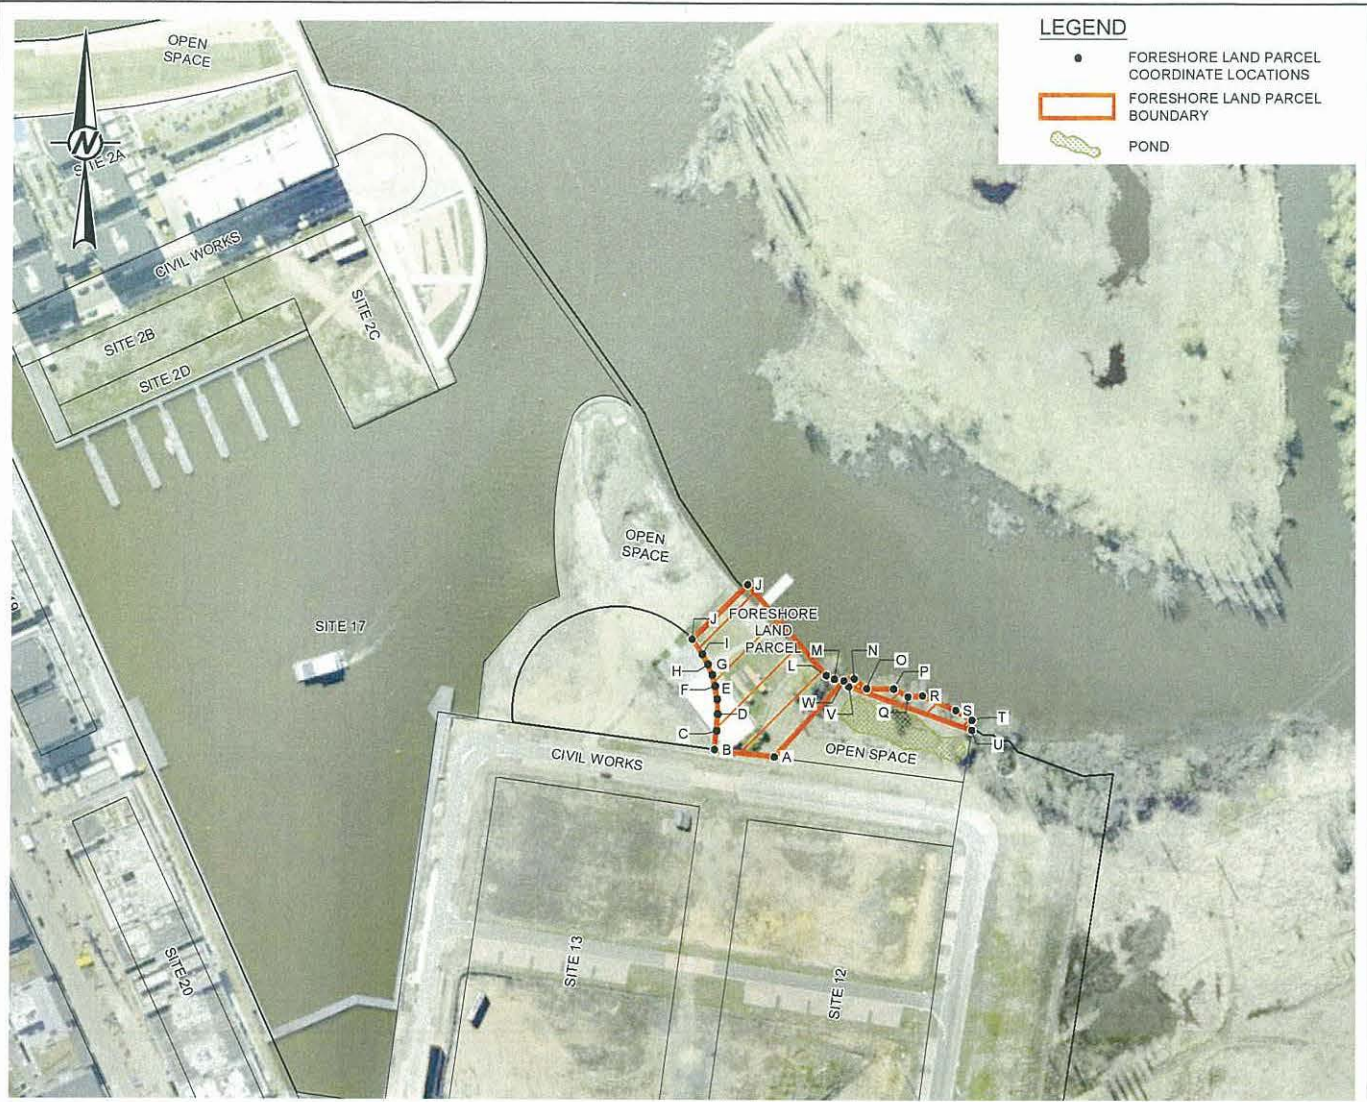
Point ID	X coordinates	Y coordinates
A	695403.78	6090163.89
B	695403.78	6090167.50
C	695404.84	6090175.26
D	695405.32	6090182.76
E	695405.23	6090188.29
F	695404.55	6090193.76
G	695403.36	6090198.43
H	695401.60	6090202.83
I	695399.29	6090207.02
J	695395.18	6090213.28
K	695418.73	6090235.35
L	695450.84	6090197.26
M	695454.21	6090195.64
N	695462.39	6090195.63
O	695467.40	6090191.50
P	695478.63	6090191.14
Q	695484.42	6090187.77
R	695490.42	6090188.03
S	695504.05	6090181.74
T	695510.72	6090177.60
U	695510.56	6090173.51
V	695460.05	6090192.39
W	695458.07	6090194.88

NOTE(S)
1. COORDINATES ARE UN GDA 1994, MGA ZONE 55 PER REFERENCE LISTED BELOW
