Heritage (Decision about Provisional Registration of former Sewage Attendant's Cottage, District of Weston Creek) Notice 2010

FORMER SEWAGE ATTENDANT'S COTTAGE

BLOCK 1168 and PART 1196 DISTRICT OF WESTON CREEK

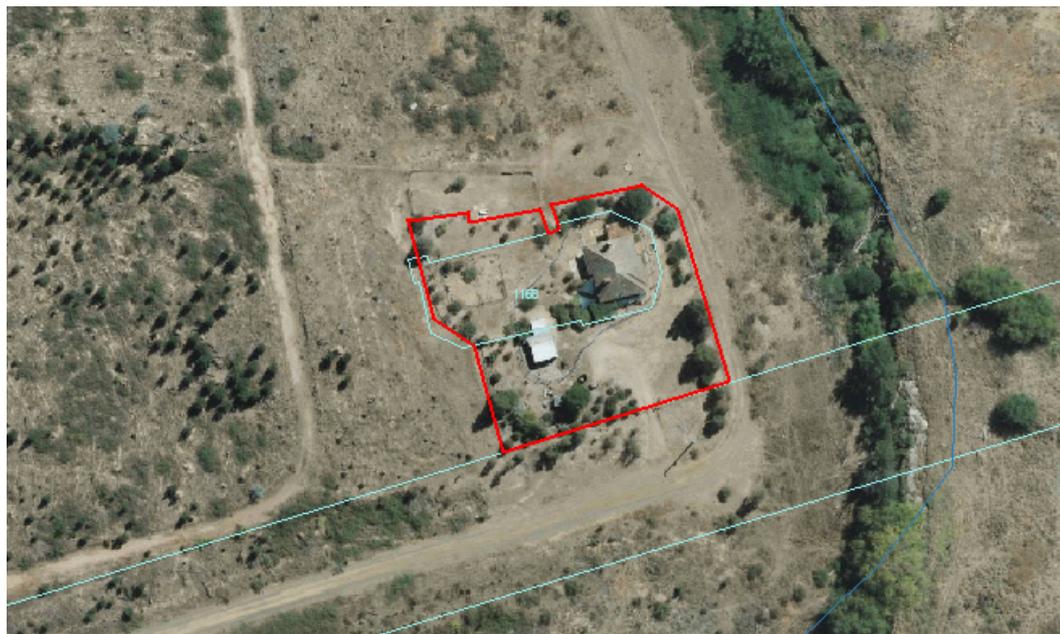
Former Sewage Attendant's Cottage boundary as defined by red line (Source: ACTMAPi)

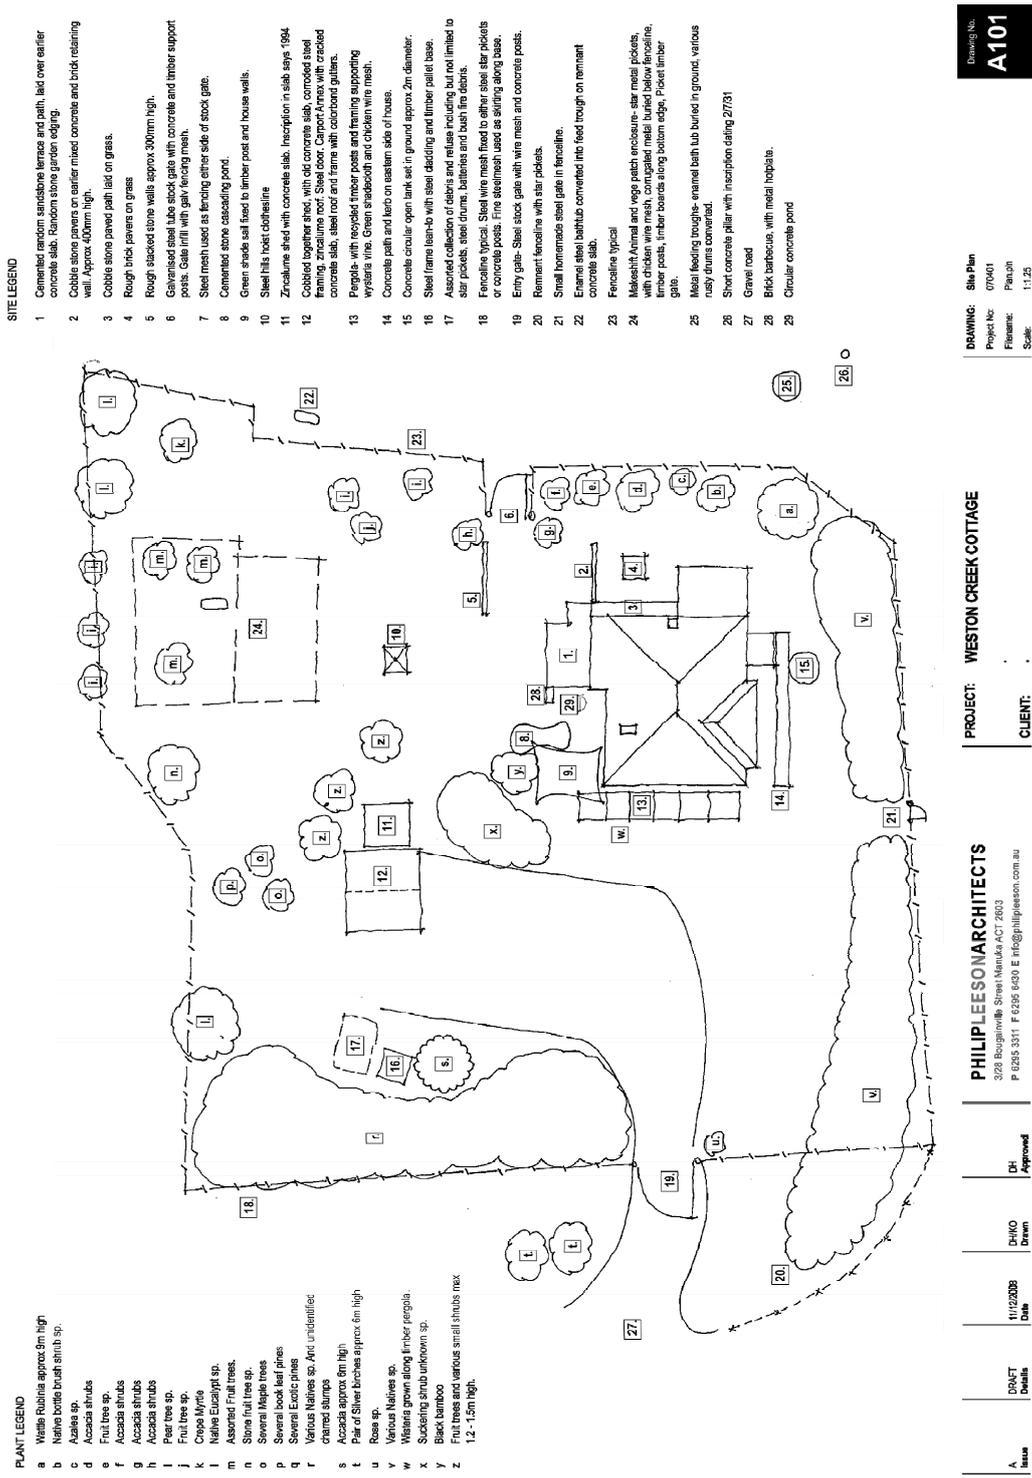
Drawing No:
A101

Site Plan and Plantings (Source: Philip Leeson Architects)

- 1 Cemented random sandstone terrace and path, laid over earlier concrete slab. Random stone garden edging.
- 2 Cobble stone pavers on earlier mixed concrete and brick retaining wall. Approx 400mm high.

- 3 Cobble stone paved path laid on grass.
- 4 Rough brick pavers on grass
- 5 Rough stacked stone walls approx 300mm high.
- 6 Galvanneal steel tube stock posts with concrete and timber support posts. Gate fill with pink fence mesh.

- 7 Steel mesh used as fencing either side of stock gate.
- 8 Cemented stone cascading pond.
- 9 Green shade sail fixed to timber post and house walls.
- 10 Steel hills hotel clothesline

- 11 Zincalume shed with concrete slab. Inscription in slab says 1984
- 12 Cobbed together shed, with old concrete slab, corrugated steel framing, zincalume roof. Steel door. Carport Annex with crested concrete slab, steel roof and frame with cardboard gutters.

- 13 Pergola - with recycled timber posts and framing supporting wisteria vine. Green shadecloth and chicken wire mesh.
- 14 Concrete path and kerb on eastern side of house.

- 15 Concrete circular open tank set in ground approx 2m diameter.
- 16 Steel frame lean-to with steel cladding and timber pallet base.
- 17 Assorted collection of debris and refuse including but not limited to star pickets, steel drums, batteries and bush fire debris.

- 18 Fenceline typical. Steel wire mesh fixed to either steel star pickets or concrete posts. Fire steel mesh used as siding along base.
- 19 Entry gate. Steel stock gate with wire mesh and concrete posts.

- 20 Remnant fence line with star pickets.
- 21 Small homemade steel gate in fenceline.
- 22 Enamel steel bathtub converted into feed trough on remnant concrete slab.

- 23 Fenceline typical
- 24 Miscellaneous and egg mesh enclosure, star metal pickets with chicken wire mesh, corrugated metal lashed below fenceline, timber posts, timber boards along bottom edge, Picket timber gate.

- 25 Metal feeding trough, enamel bath tub buried in ground, various rusty drums converted.
- 26 Short concrete pillar with inscription dating 27/791
- 27 Gravel road

- 28 Brick barbecue, with metal hoplite.
- 29 Circular concrete pond

2. The site within the existing perimeter fencing, including;
- Plantings immediately adjacent to the house and objects and plantings within the existing fenced curtilage as listed on the following site plans at ***Site Location and Plans***

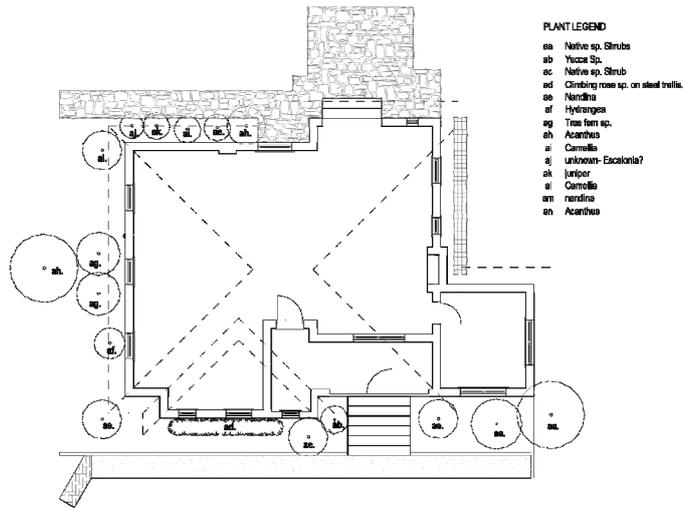
Drawing No
A102

DRAWING: Particular Planting
 Project No: 071421
 Filename: Plan_09
 Scale: 1:100

Plantings adjacent to the Cottage (Source: Philip Leeson Architects)

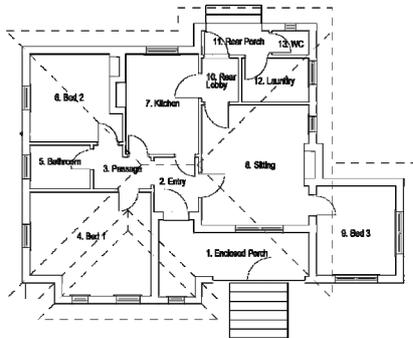
Drawing No
A103

DRAWING: Floor Plan
 Project No: 071421
 Filename: Plan_09
 Scale: 1:100

Floor Plan (2009) (Source: Philip Leeson Architects)

In its present form the house comprises front verandah, entry hall, sitting room, 3 bedrooms, bathroom, kitchen, rear lobby, back verandah, laundry and toilet.

1940/41	Bedroom 3 added.
1970's?	Front veranda enclosed
1980's?	Original kitchen / hall closets removed Bathroom upgraded Modern electrical fit out Modern paint finishes and floor coverings Modern sink, bathroom basin, toilet and laundry trough Slow combustion stove to Sitting Room Modern roller blinds Modern toilet cistern

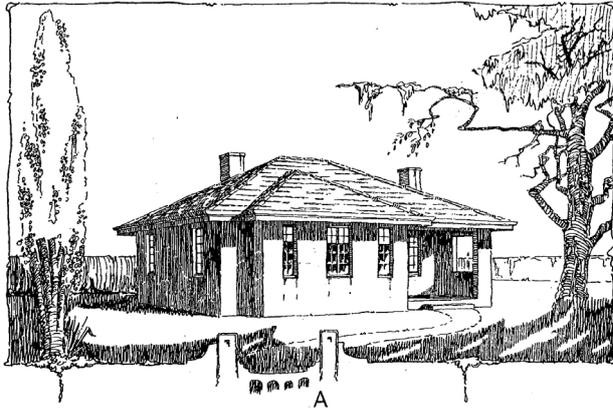
TYPE
F.C.C. 20 G.3

Area of Cottage 998 square feet
 Area of Verandahs 193
 Total Area 1,191

FCC Type 20 Plan (Source: *Canberra, General Notes for the Information of Public Servants. Federal Capital Commission, 1926*)

The former Sewage Attendant's Cottage is a Federal Capital Commission Type 20 G.3. It was one of a number of standard house types built by the FCC to accommodate low to middle ranking public service officers in 1926-27, many transferred in advance of the opening of Federal Parliament in May 1927.
